Manhole Inspection Summary

Manhole # S27AA_046MH

Insp Date: **8/17/09 9:04 AM**

Location Address: **SHIELDS PL**

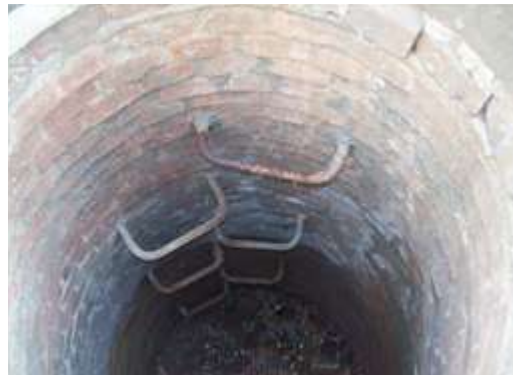
Defect 2

Count: **6** Missing: **0** ☒ **Corroded**

CORRODED STEPS

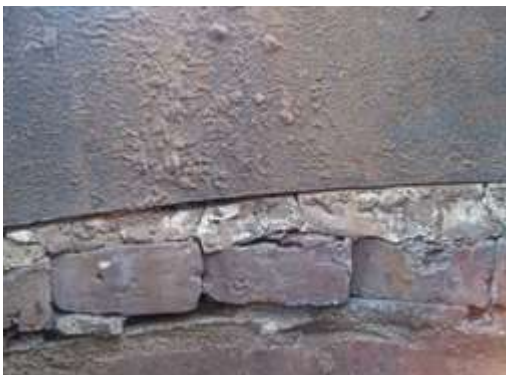
Defect 1

Condition: ☐ Sound ☐ Cracked ☐ Root Intrusion ☒ **Loose Brick** ☐ Deteriorated

LOOSE BRICKS AT CORBEL

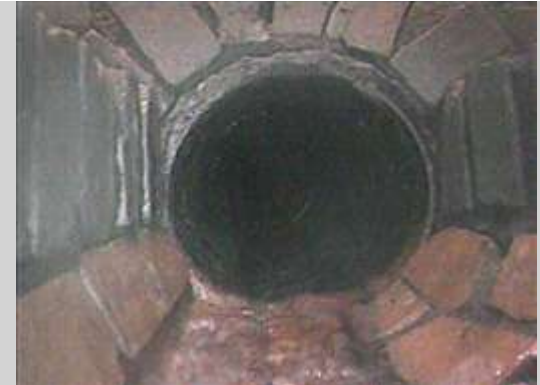
12 O'Clock Outflow

8 in. Circular Gravity Sewer
Pipe Out @ 12 O'Clock

Pipe Height: (in.) Direct
Pipe Material: **Clay** ☐ Pipe Lined
Invert Depth: **10.54** (ft.) Flow Characteristics: **Slow**
Deposits: ☒ None ☐ Mud ☐ Sludge ☐ Debris ☐ Grease
Silt Depth: (in.) Deposits Extent:
Infiltration: **None** Pipe Seal Cond: **Sound**

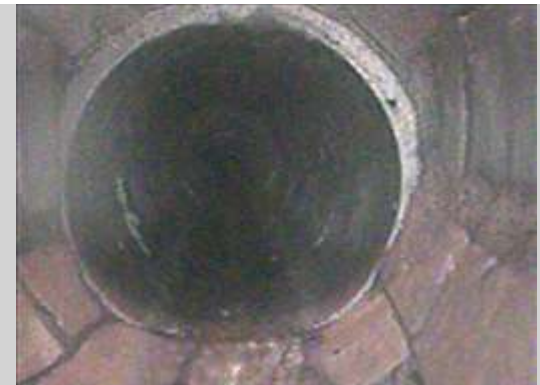
3 O'Clock Inflow

8 in. Circular Gravity Sewer
Pipe In @ 3 O'Clock

Pipe Height: (in.) Direct
Pipe Material: **Clay** ☐ Pipe Lined
Invert Depth: **10.45** (ft.) Flow Characteristics: **Slow**
Deposits: ☒ None ☐ Mud ☐ Sludge ☐ Debris ☐ Grease
Silt Depth: (in.) Deposits Extent:
Infiltration: **None** Pipe Seal Cond: **Sound**

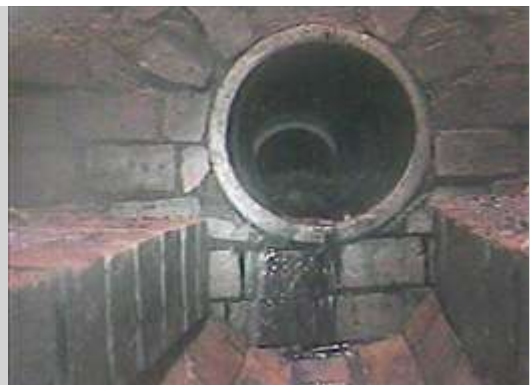
6 O'Clock Inflow

8 in. Circular Gravity Sewer

Pipe In @ 6 O'Clock

Infiltration: **None** Pipe Seal Cond: **Sound**
